YOUR INSPECTION REPORT

283 Kennedy Avenue
Toronto, ON M6P 3C4

INSPECTION DATE:
Thursday, May 19, 2022

RE: Report No. 7062
283 Kennedy Avenue
Toronto, ON
M6P 3C4

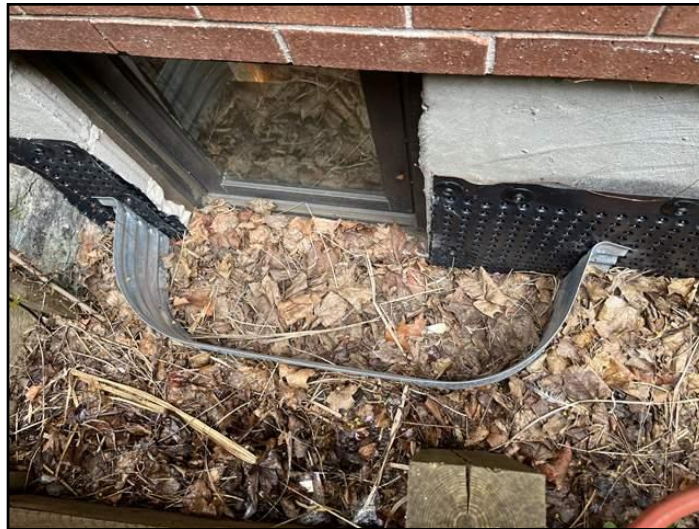
Condition: • Debris/Dirty

Location: Right Side Exterior

4. Debris/Dirty

Time: Regular maintenance

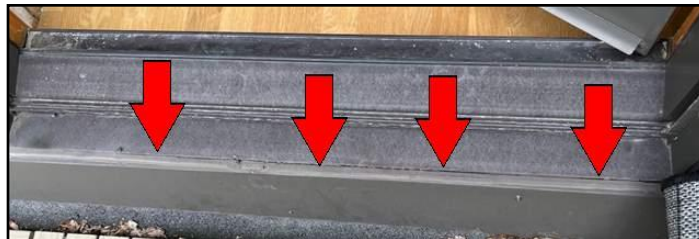
Condition: • [Caulking missing, deteriorated or loose](#)

5. Caulking missing, deteriorated or loose

Time: As soon as practical

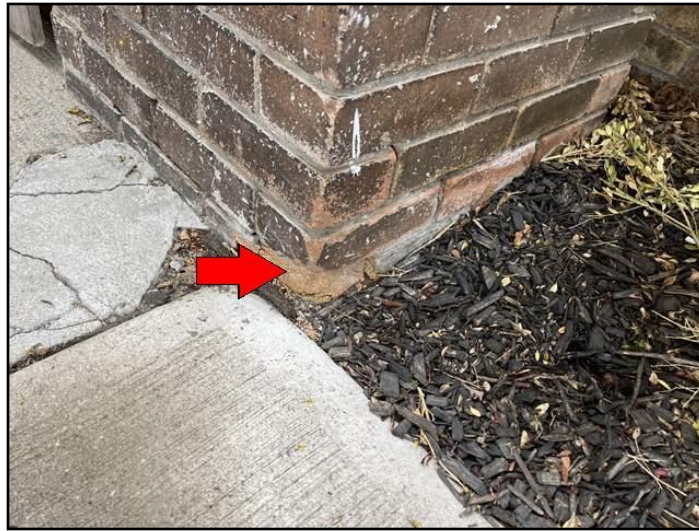
Condition: • [Spalling](#)

6. Spalling

Task: Repair

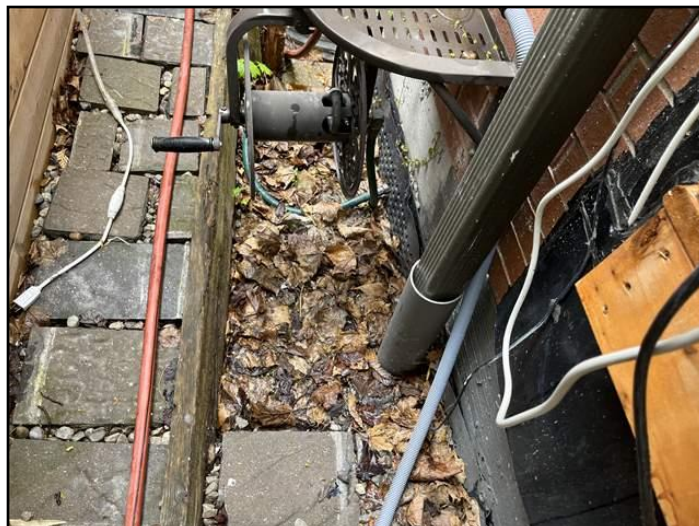
Condition: • Low Areas.

7. Low Areas

Task: Monitor / Improve

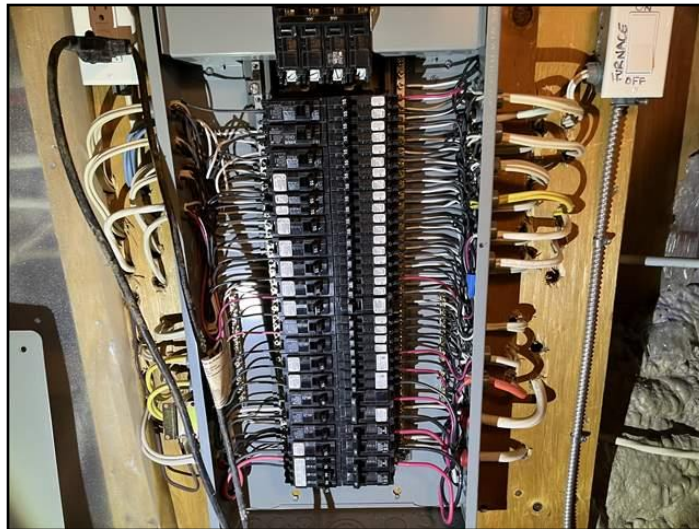
Very good condition overall

8. Breakers - basement

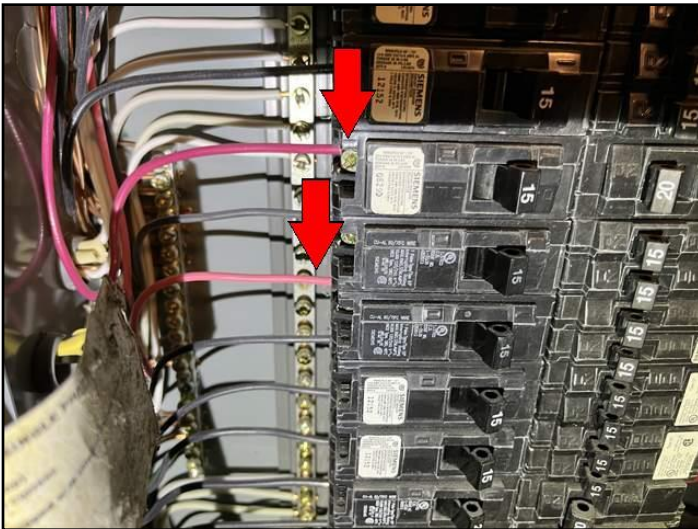
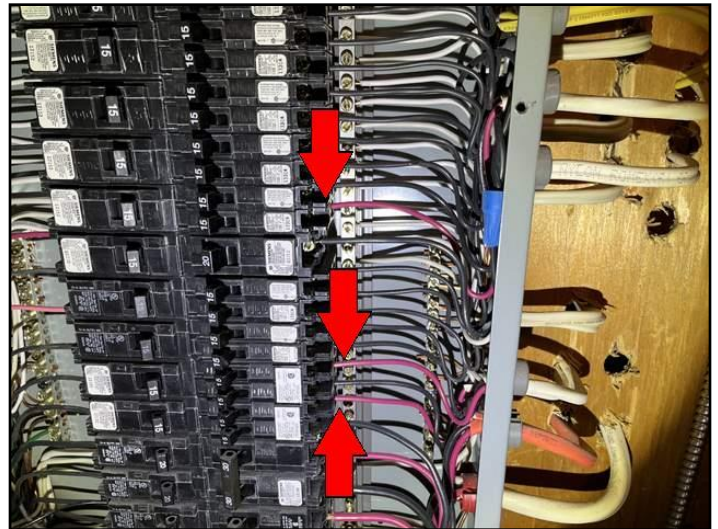
Condition: • [No links for multi-wire circuits](#)

Missing links(breaker bridge) Have electrician confirm if distribution lines are multi-wire circuits. Provide links if

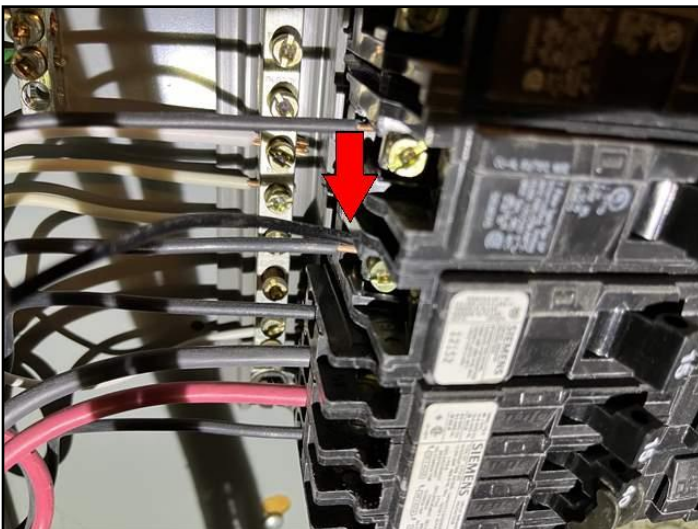
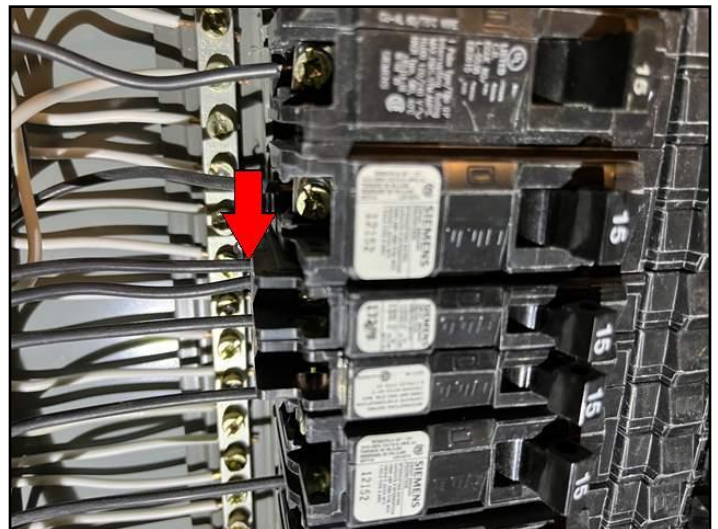
Double taps noted including low voltage wire connection to breaker. Although we see this frequently, it is not permitted.

11. Double taps

Pigtailing recommended

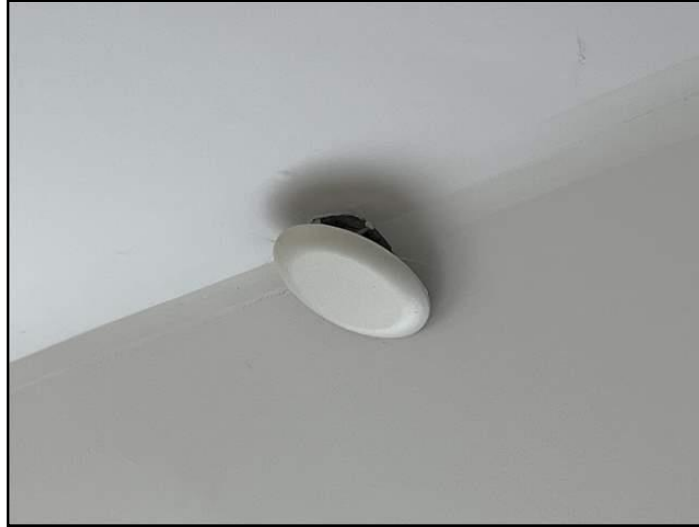
Condition: • [Cover loose or missing](#)

13. Cover loose

Task: Correct

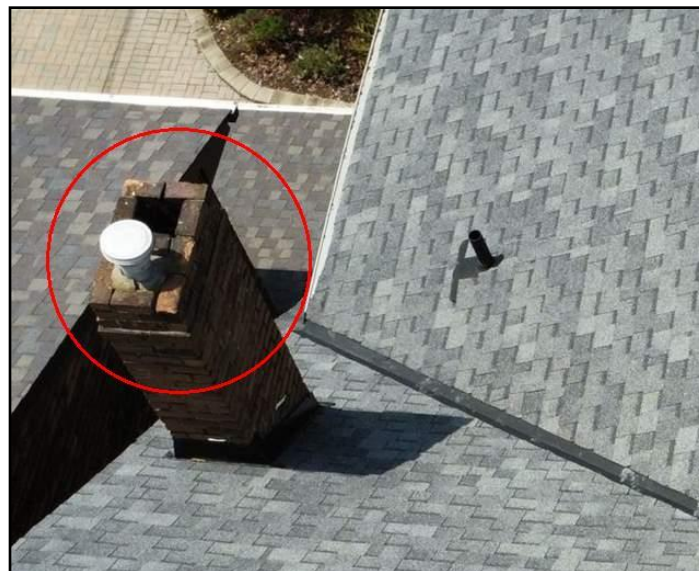
Condition: • [Missing](#)

14. Missing

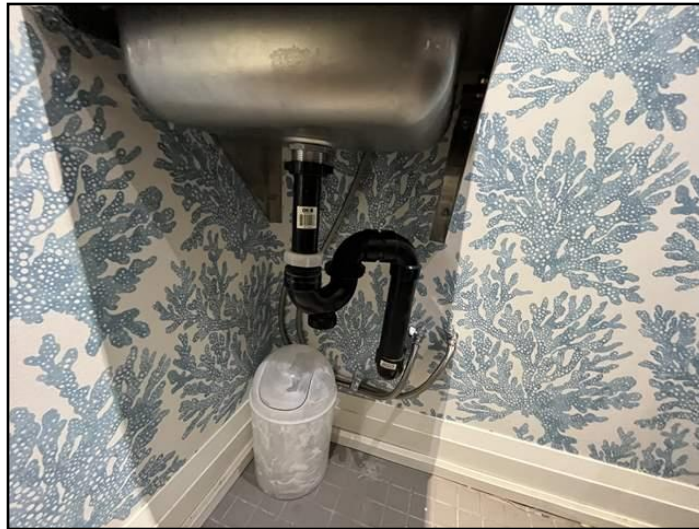
Condition: • [Nonstandard shape or material](#)

16. Nonstandard shape

Task: Replace

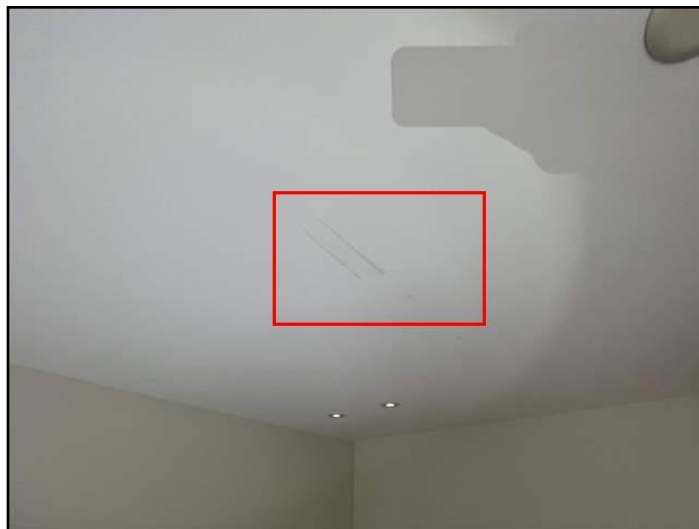
Condition: • Stains

Tested with moisture meter. Dry at time of inspection

Location: Second Floor Primary Bedroom

17. Stains

Task: For Your Information/Monitor
